Re: Final Report, Geotechnical Evaluation of Landslide Near SR-3 and Gorst Creek  
Gorst, Washington

April 22, 1997  
HWA Project No. 97063

Subject: **Geotechnical Evaluation**  
**Gorst Creek Landslide**  
**SR-3 at Gorst Creek**  
**Gorst, Washington**

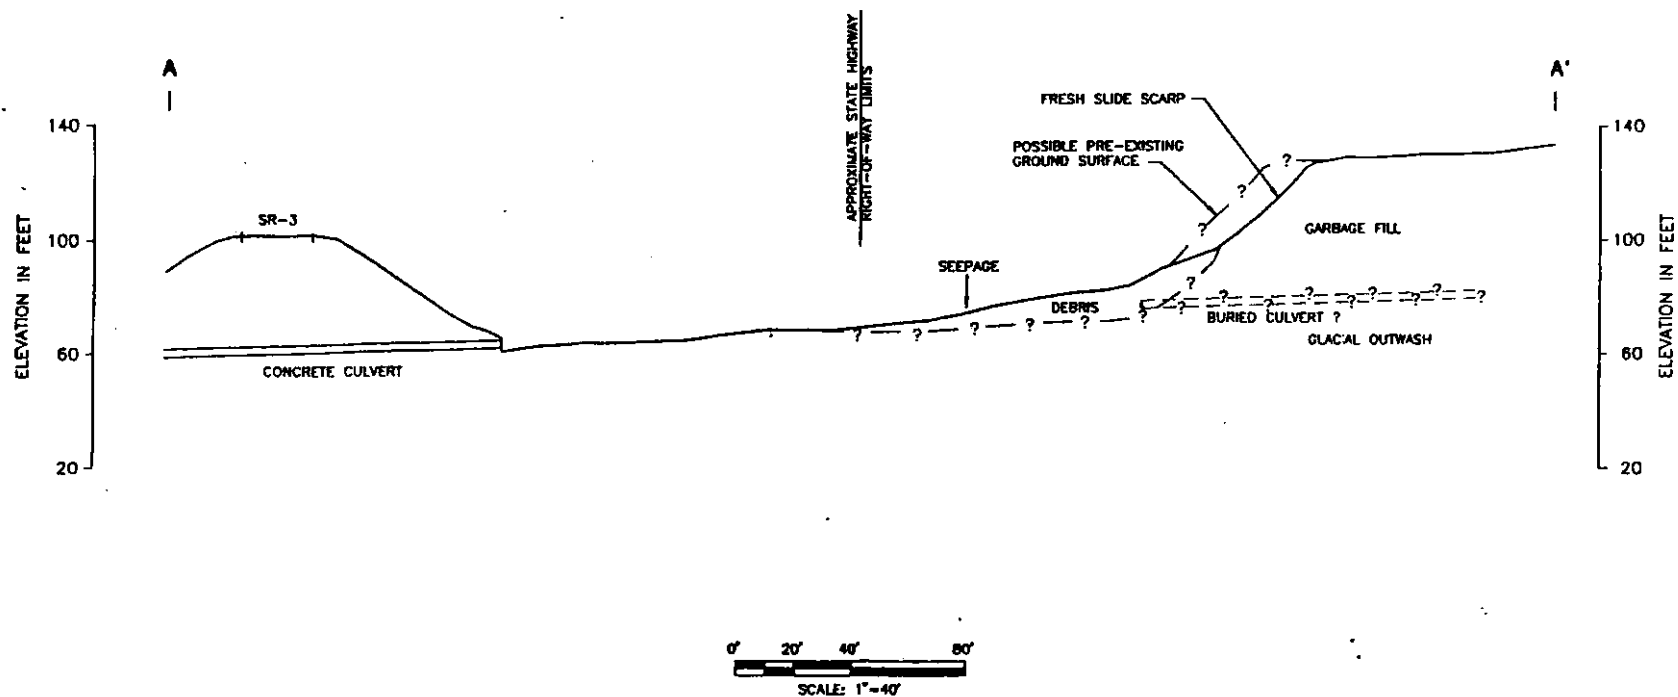
FIGURE 3

The landslide consists of a steep scarp, approximately 20 feet in height, with debris (garbage) deposited on the lower slope as shown on Figures 2 and 3. The scarp exposes garbage from the landfill, while the lower portion of the slide is garbage debris mixed with sands and gravels.

Results of our reconnaissance indicate that native soils at the toe of the slope likely consist predominantly of glacial outwash sands and gravels. On the higher slopes towards the outer edge of the failure, thinly bedded, dense silts and fine sands were noted.
